# Quality Control Issues in CDF Silicon

Steve Worm  
University of New Mexico / CDF

For the CDF Silicon Groups  
May 17, 2001

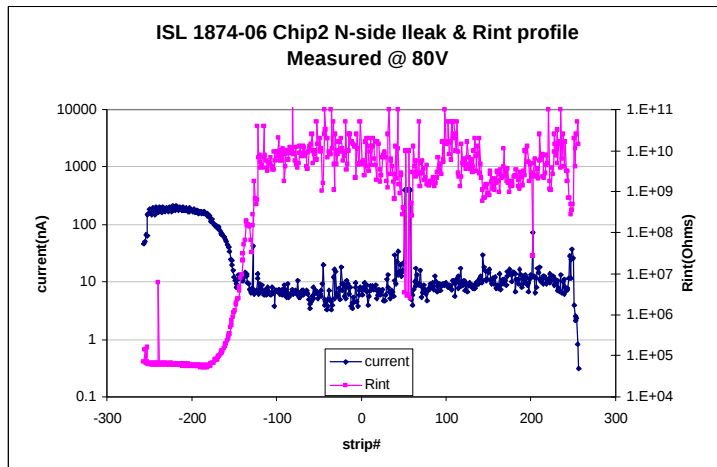
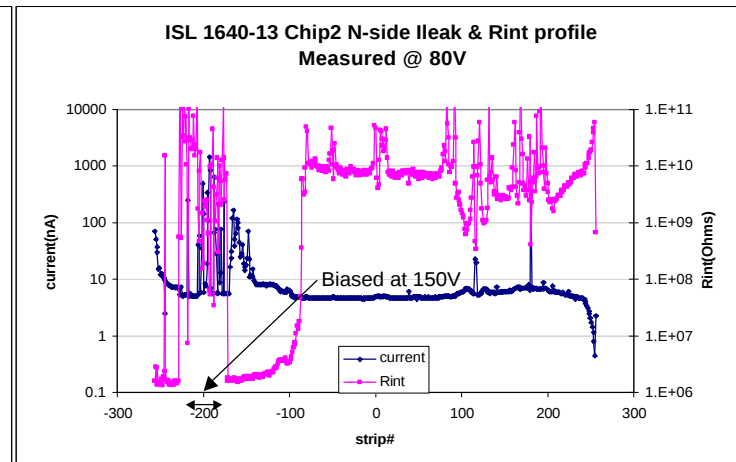
# Interstrip Resistance

- Many factors lead to isolation problems for CDF
  - Hamamatsu – mobile ionic contaminant
  - Micron – change in cutting film results in poor isolation (localized contaminant)
  - Micron – process variations and possibly bulk Si
- Test for  $R_{int}$  necessitates DC pad probing

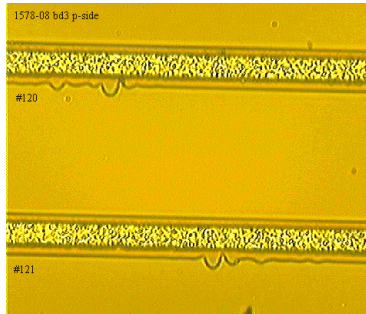
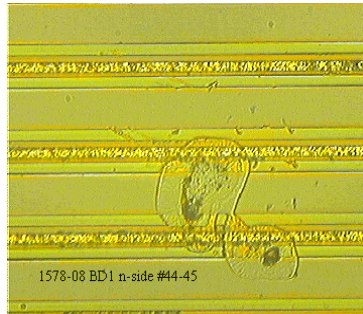
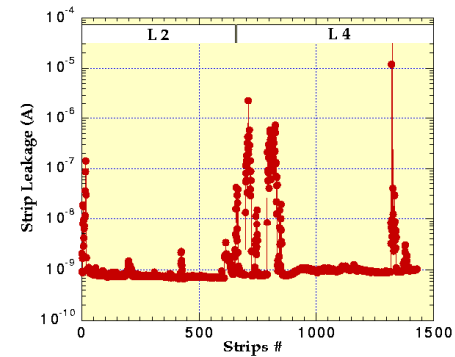
# Leaky Strips

- Process defects (and poor handling, cleaning) lead to leaky strips
- Hamamatsu
  - DC shorts seen from scratches during processing
  - Surface scratches (a major problem)
- Micron
  - Lack of cleanliness in the cleanroom drove the generation of leaky strips early on
  - Specification changed to have strips with  $> 100$  nA counted as bad.

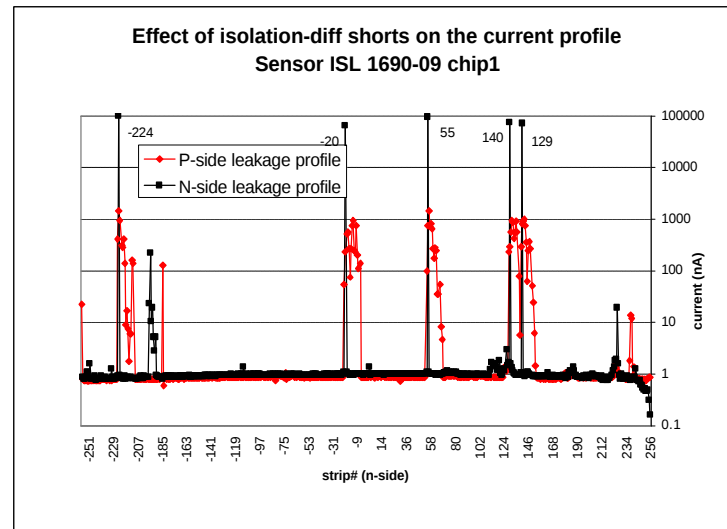
# Diff-Isolation Faults

- Micron Photolithography faults between n implant and p-stop
  - Ramp-up of 150 mm production allowed non-optimal (bad) photolithography
  - Photoresist surface drying allowed solvent to be trapped (oven, not hot plate)
  - Trapped solvent during exposure led to semi-circular defects near the edges of the p-stops that created one very leaky strip
  - Small angle stereo, plus isolated p-stops, yielded a region of leaky strips on the p-side.

This problem forced significant retesting of all devices from Micron.

Subsequently, working closely with Micron allowed us to see, predict, and fix problems before they reached us.

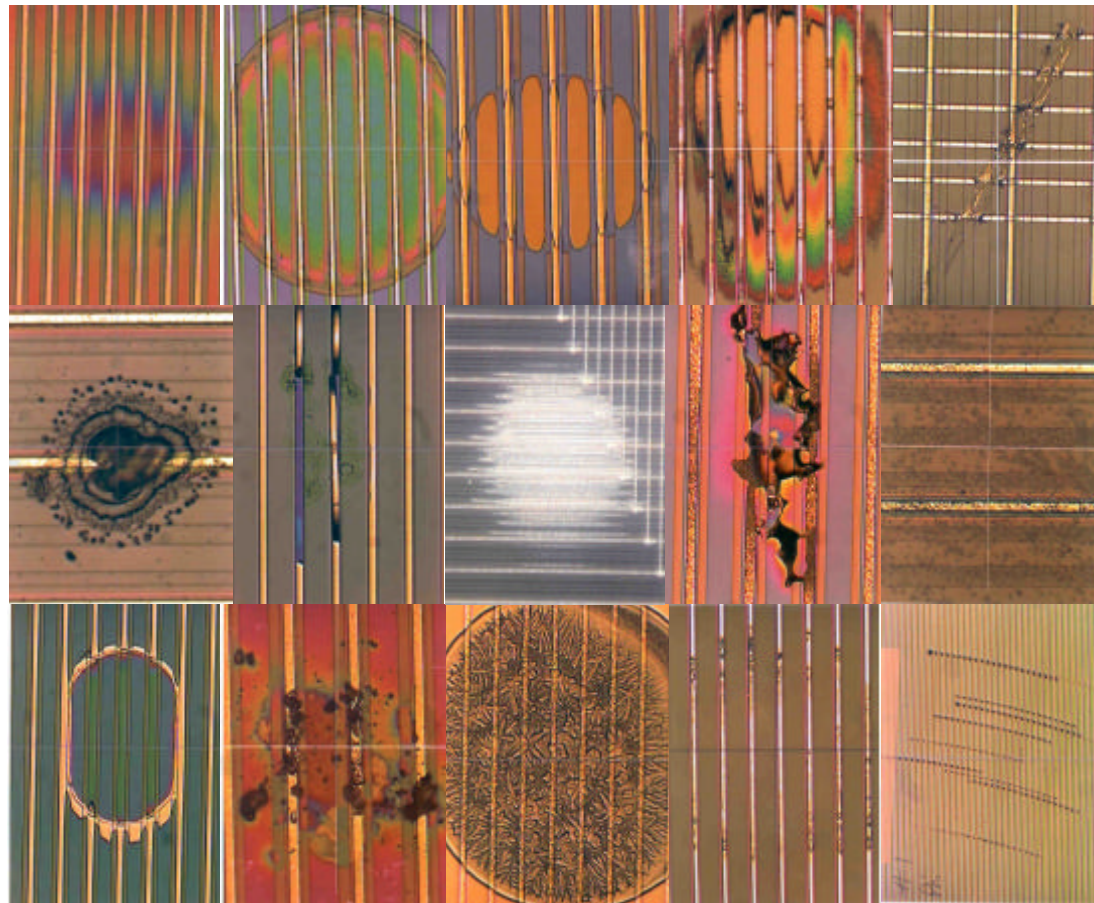
## Process Defects and Scratches

- CDF SVXII readout hybrids are glued directly to the silicon
  - Epoxy used does not affect sensor *if passivation is intact*
  - Scratches present on sensors from both vendors
  - Some process flaws also
- Inspection and coating of scratches on every sensor was necessary
  - Very labor intensive (~1 man year)
  - Coating conducted at Fermilab
  - UV cure epoxy (Norland)
- Hamamatsu sensors
  - About 75% needed coating
  - 3.0 or 0.7  $\mu\text{m}$  passivation
- Micron sensors
  - Only about 20% required coating
  - 0.2 to 0.3  $\mu\text{m}$  passivation (LPCVD  $\text{SiO}_2$ )
