CDF Silicon Detector

Wire-Bond Failures Induced by Resonant Vibrations

Reid Mumford

CDF Collaboration

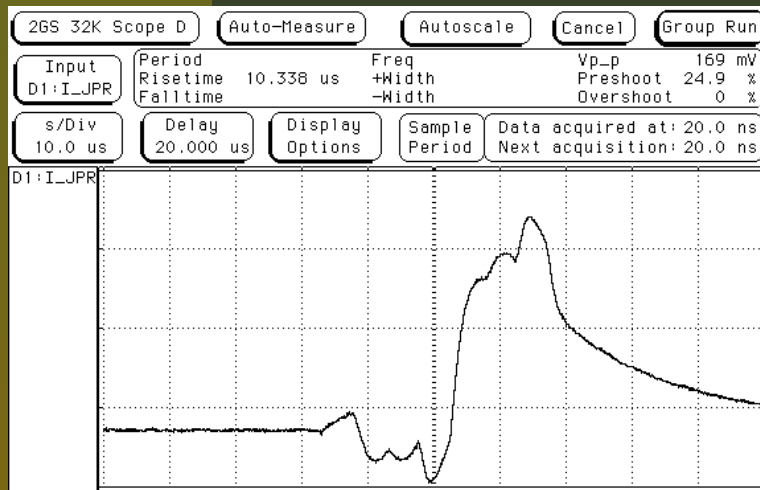
DOIM and Jumper Currents

- DVDD Jumpers have ΔI up to 150mA
- I_{max} occurs when readout shifts from ϕ to z chips

- DOIMs have ΔI of no more than 40-50mA (top trace)
- Current swings come from switching between laser diode and dummy loads

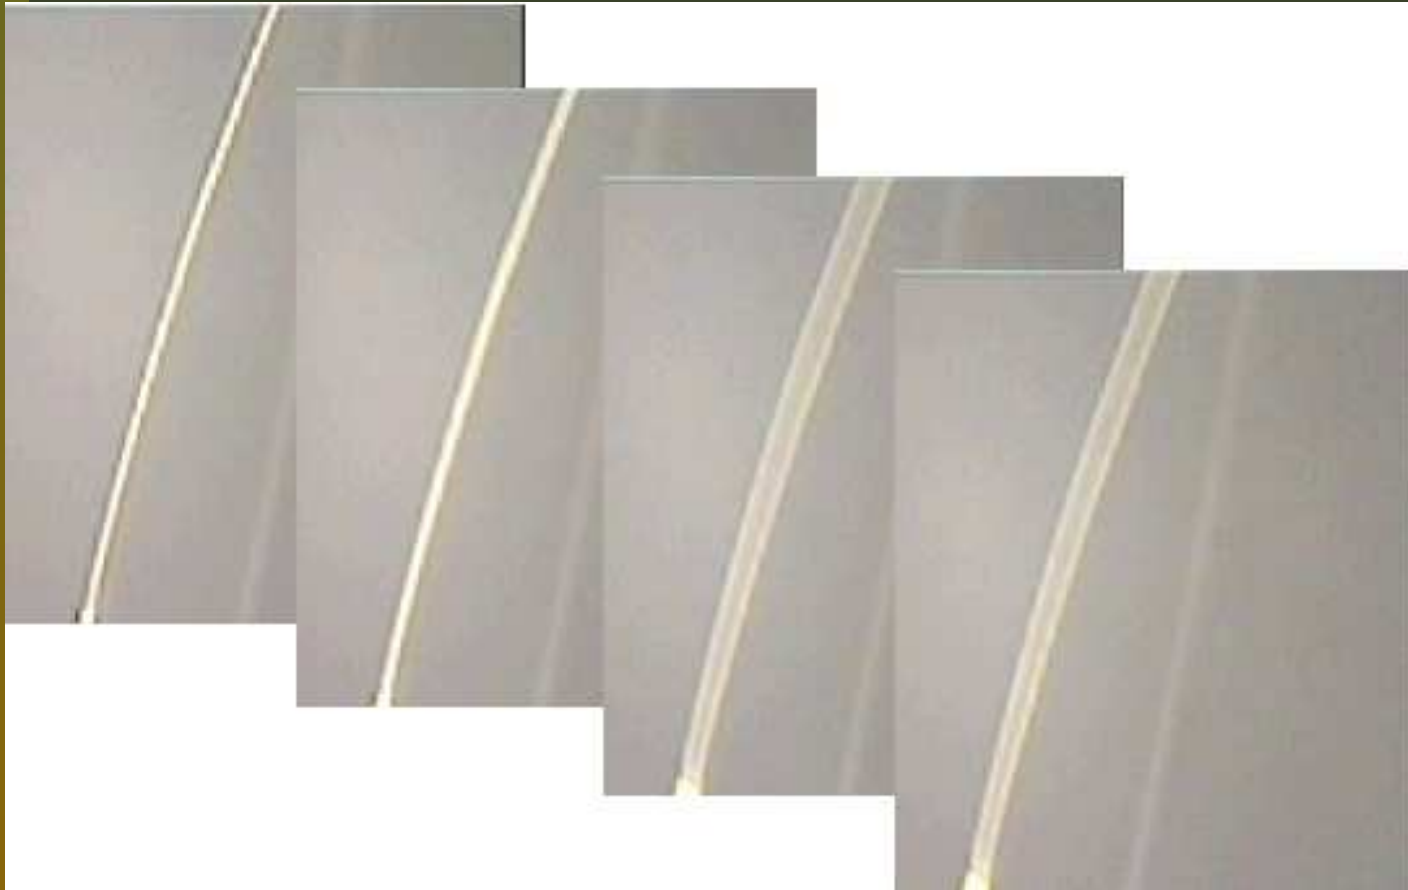
- Resonance enhances fatigue due to Lorentz forces
- Visually scanned for resonance in bonds in a 1.4T test magnet
- Resonances observed with driving currents of 10mA - 150mA.

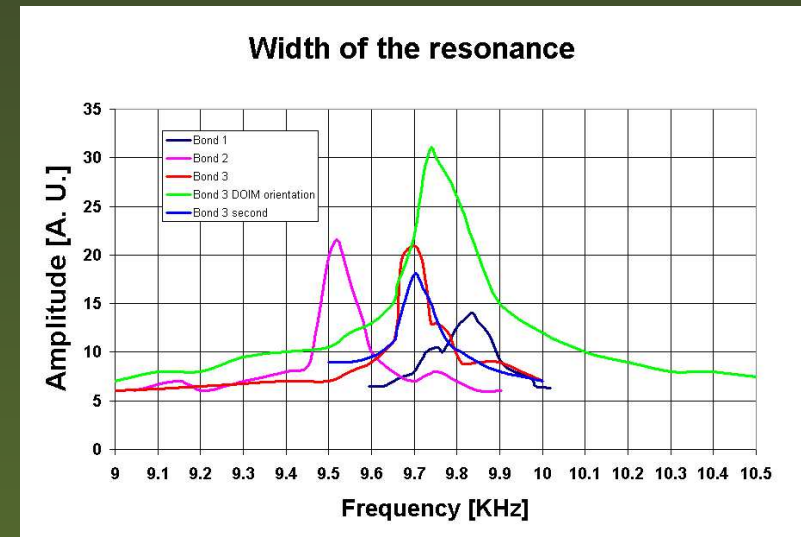
More Realistic Currents

- Bonds driven with a more realistic current pulse (100mA, 15 μ S) exhibit more resonances.
- Resonant frequency f can be excited with pulses at f , $f/2$, $f/4$, etc
- Width of resonance is between 1 and 200Hz.
- Differently shaped bonds imply different frequencies.

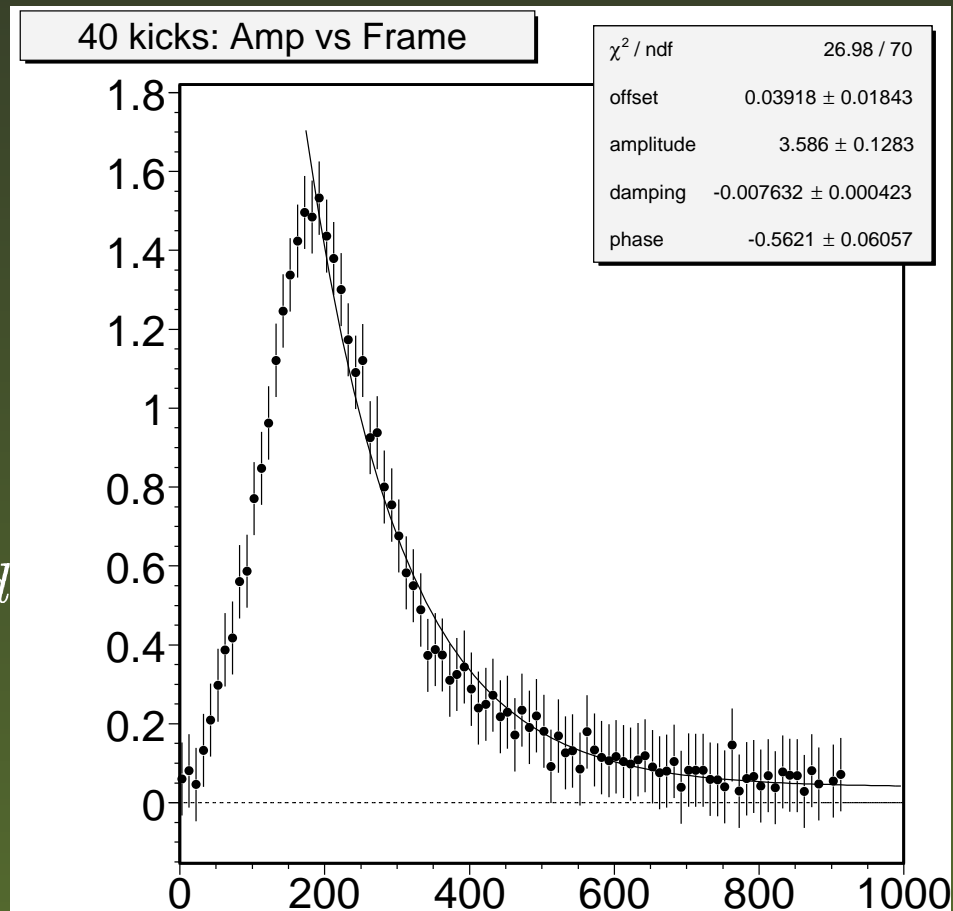
Free Oscillation

- Bonds were excited w/ a limited number of $16\mu S$, $75mA$ current pulses
- The amplitude was measured as a function of the number of pulses
- The damping ratio was also measured from the decay of the free oscillations to be roughly 0.01

$$y = A + Be^{cx-d}$$
