# The Quality Assurance during the production of the ZEUS Micro Vertex Detector

CERN, 17<sup>th</sup> May 2001

Universitaet Hamburg  
for the ZEUS MVD Group

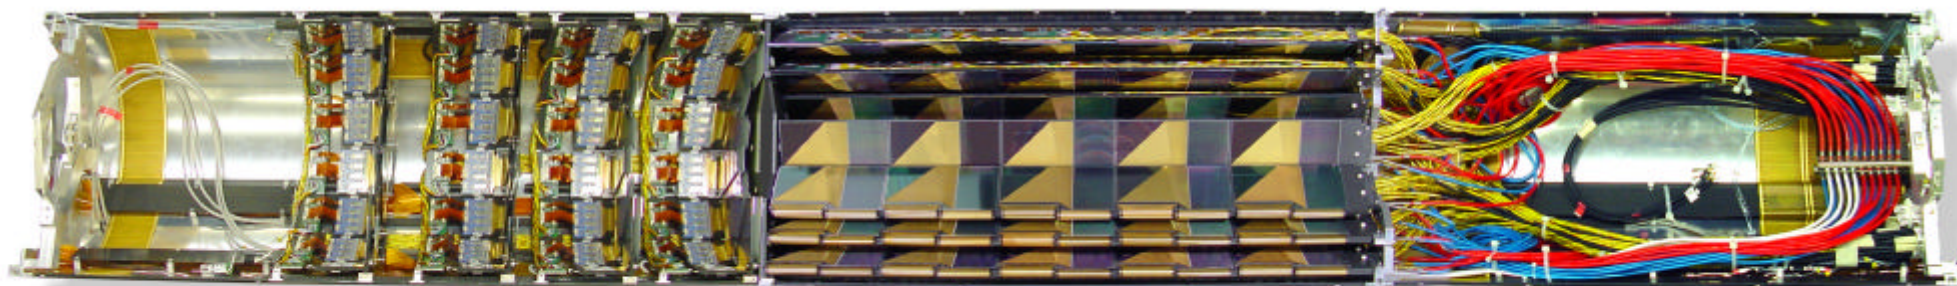
# MVD layout

BOTTOM MICRO VERTEX DETECTOR

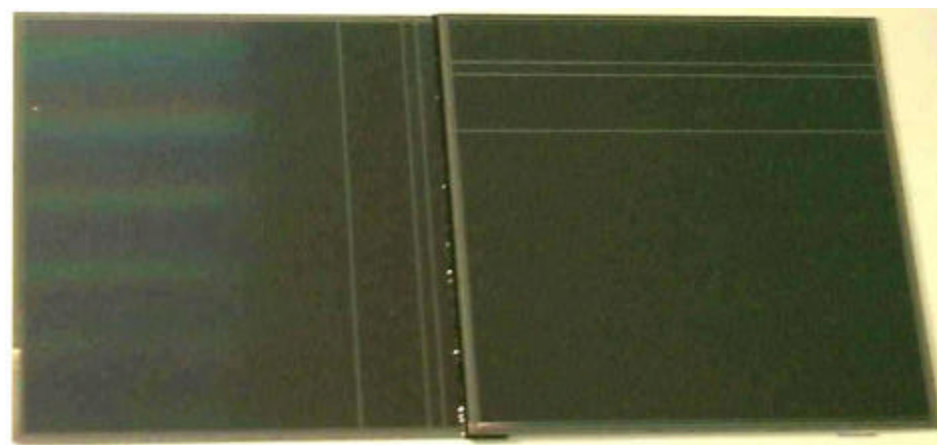
## (2) Half Module gluing

- Alignment meas.
- I/V meas.
- shape meas.

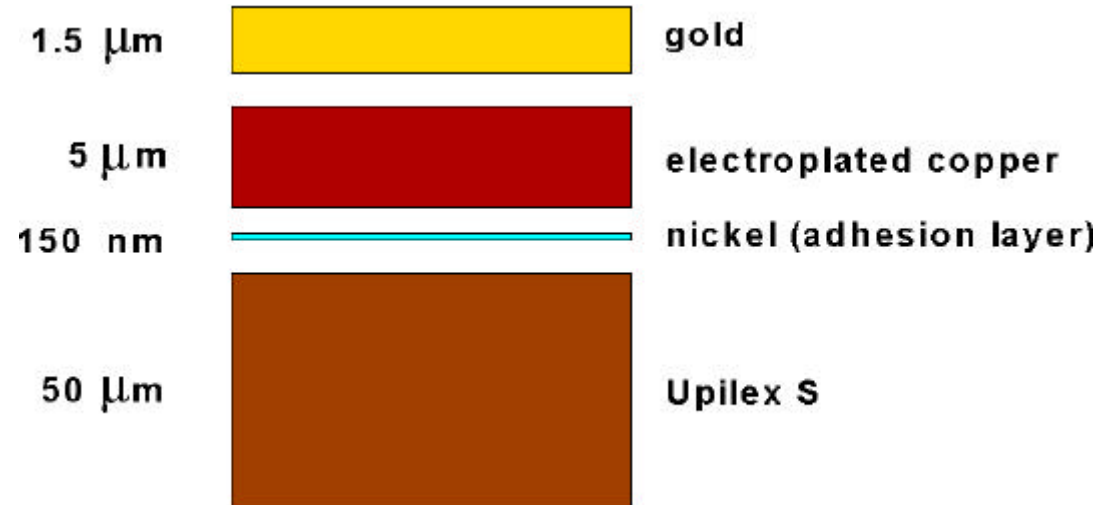
### Acceptance tests:

- visual scan
  - mask/cut errors;
  - missing gold (strip interruptions?)
  - quality of bond pads area;
- electrical measurements (R):
  - short between strips;

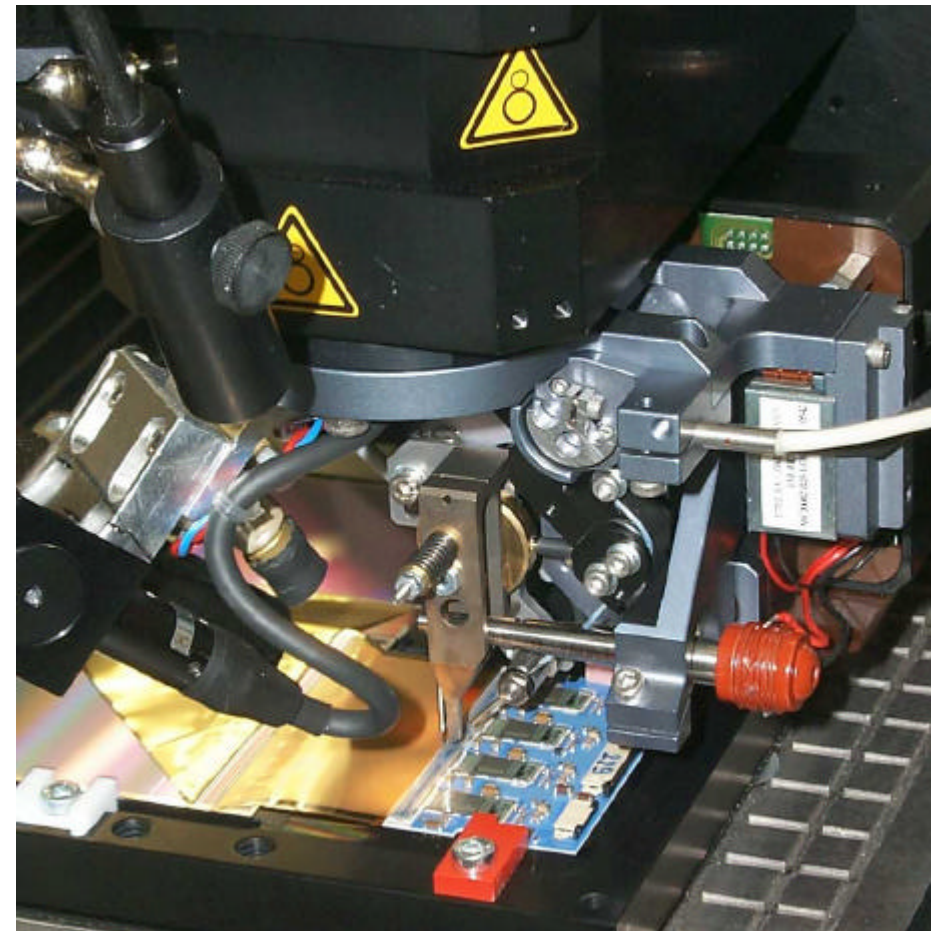
# Wire bonding

Need ~ 2000 bonds/half module

Full automatic machine : DELVOTEC 6400.

Measure the wire deformation while bonding: check bond quality.

- wire thickness  $17.5\ \mu\text{m}$ ;
- bond force ~ 5 cN;
- loop height  $< 1\ \text{mm}$ ;
